# The Arctic Building

# The Problem

# Future-Proof – The Concept

# 10 Principles of Future-Proofing Historic Buildings

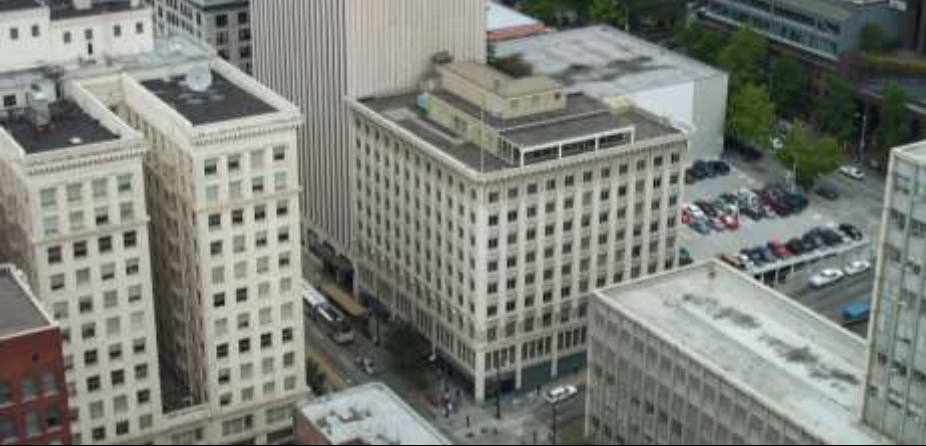
Figure 1: Aerial photo of the Arctic Building from the Southwest. Credit: City of Seattle Archives, SPU Fleets and Facilities Department "Imagebank" Collection. Item No: 120399

- **Designed and built in 1917**
- **Originally the home of the Arctic Club**
- **Finest example of a multi-colored matte glazed decorative terra-cotta building in the Northwest**
- **Original use as offices for the Club, leasable offices, private rooms, and flexibility for the tenants**
- **Adaptively used through the mid-20<sup>th</sup> century as offices for the City of Seattle**
- **Sold to the City of Seattle in 1988**

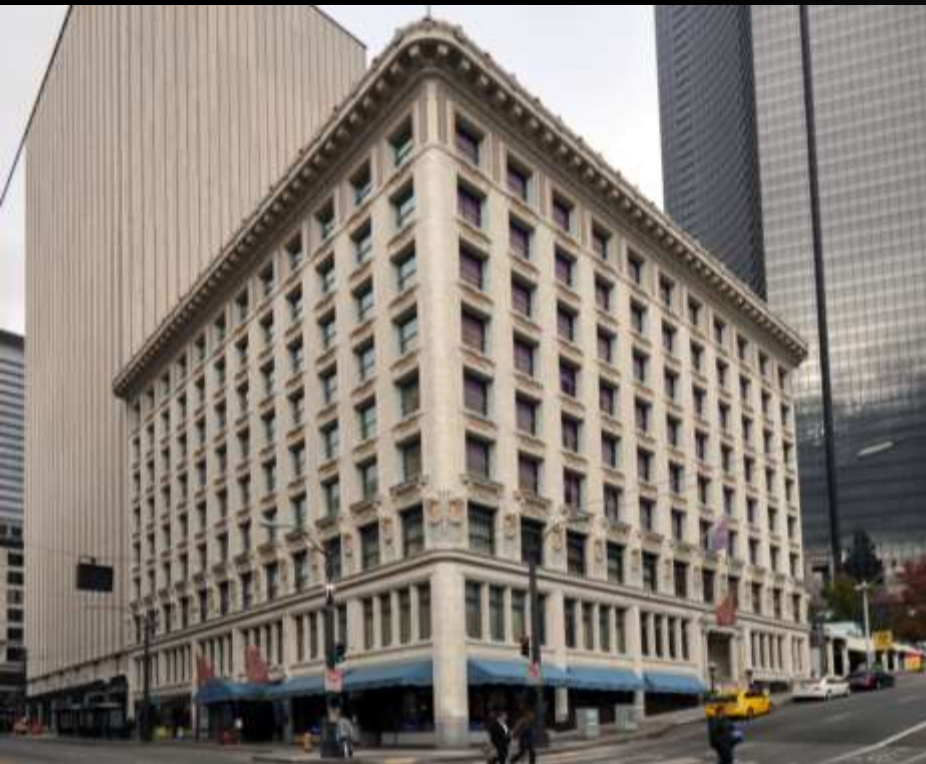
Figure 2: The Third Ave and Cherry Street corner of the Arctic Building. Credit: Brian Rich, 2013

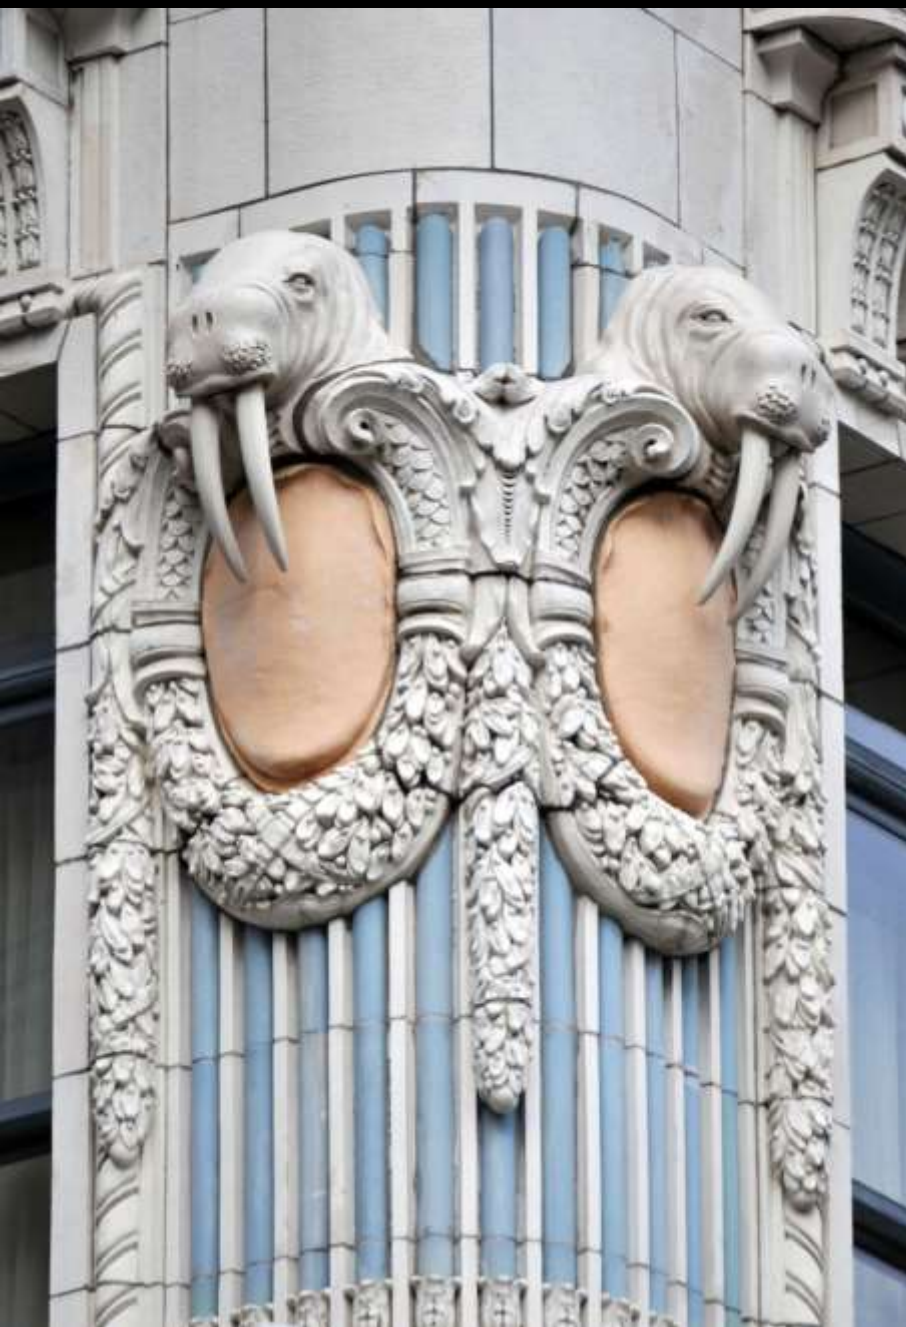
- Walrus heads decorate the Third Floor frieze
- Walrus tusks held in place with mild steel reinforcement
- Corrosion of the steel led to failure of the tusks in the 1970's and early 1980's

Figure 3: A walrus head at the Arctic Building, Seattle, WA. Credit: Brian Rich, 2013

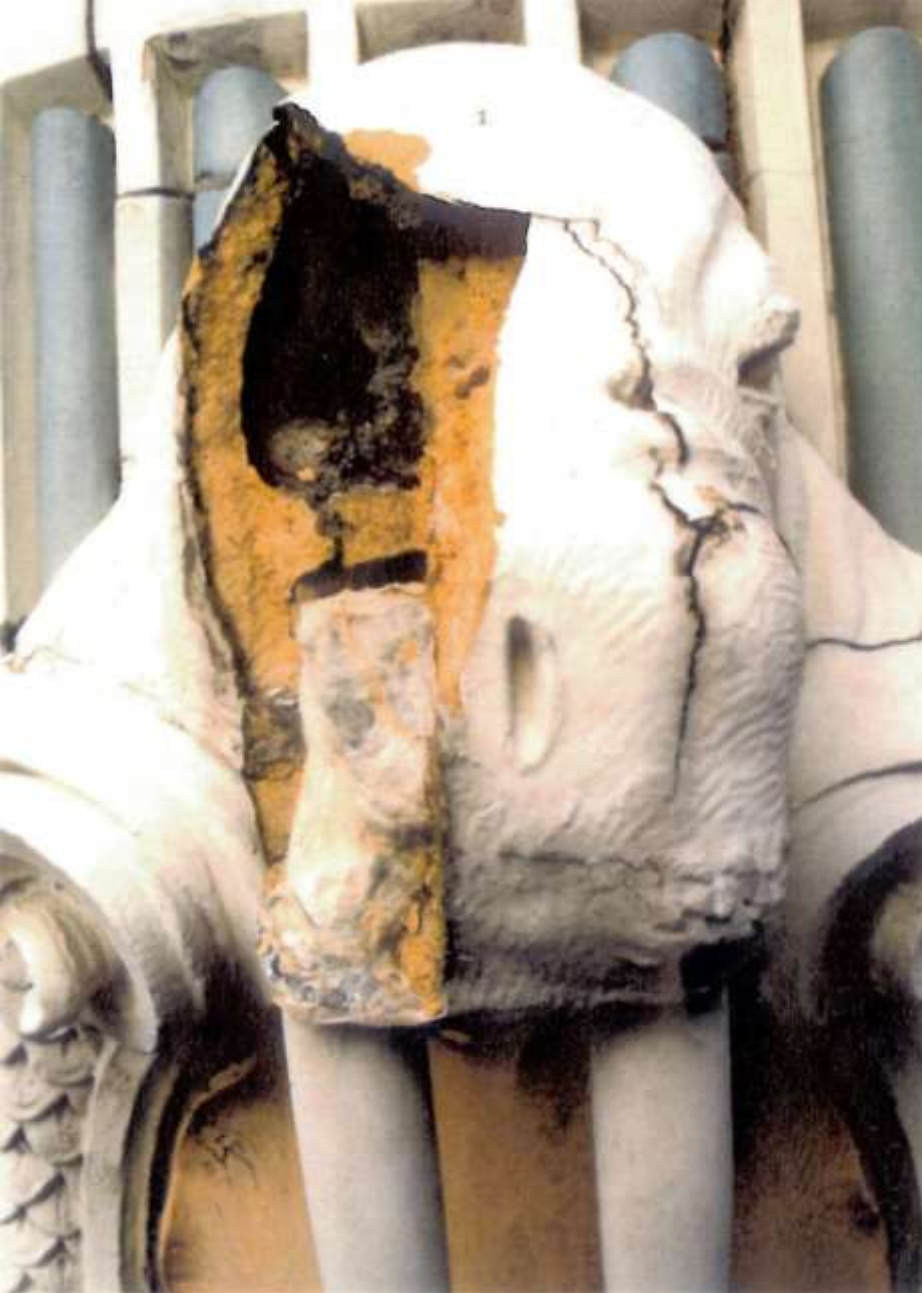
- A 1995 investigation found that the gypsum reacted to water penetration forming ettringate.
- Ettringate expanded uniformly and put pressure on the terra cotta.
- Flaws in the 1982 repair also included drilling the grout hole on top of the head rather than on the vertical face of the snout

Figure 2: Fractured terra cotta walrus head. Note the degree to which the grout fills the terra cotta void. Credit: Wiss, Janney, Elstner, 1995

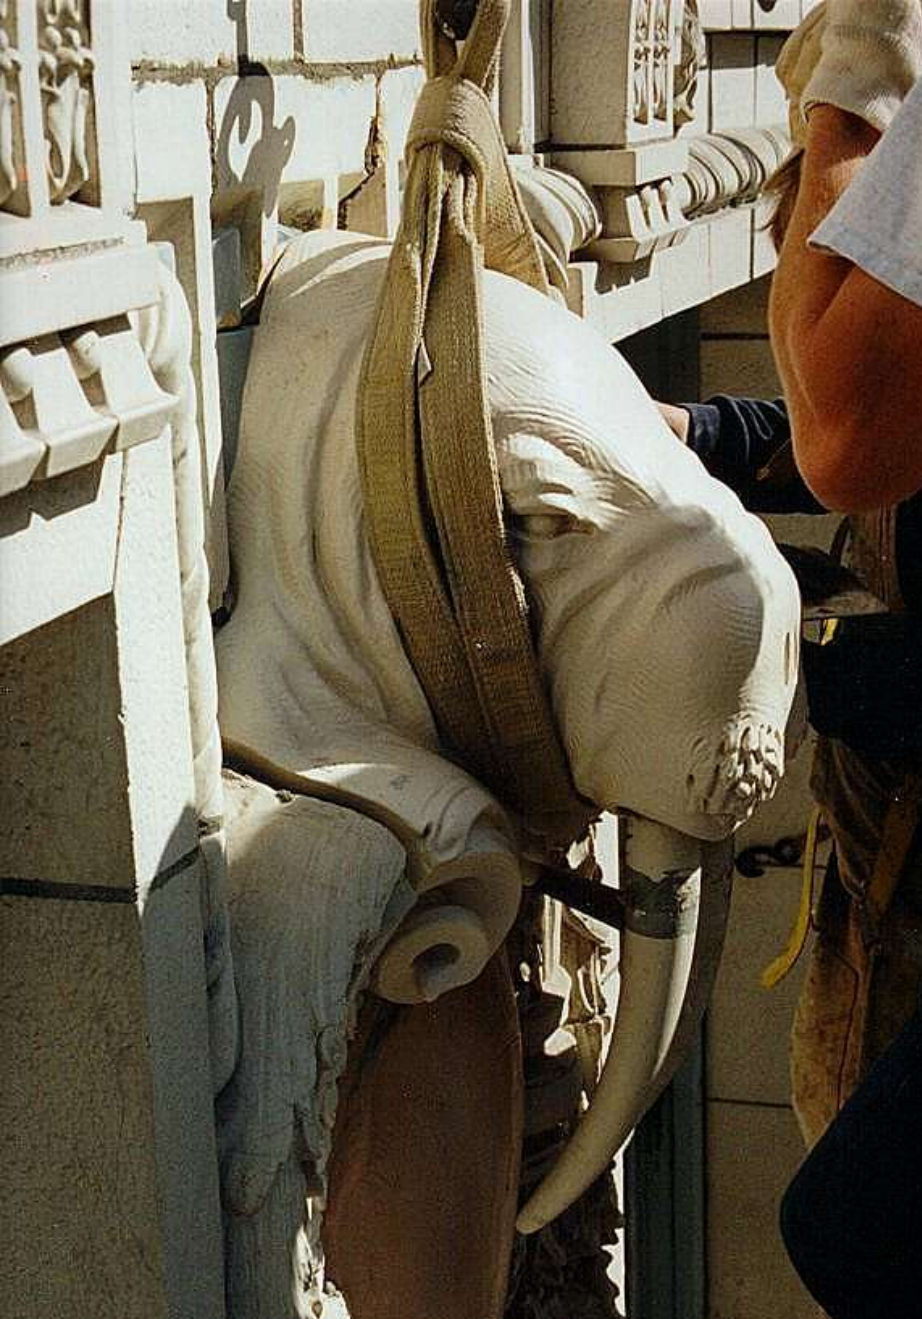
- 15 of the 27 walrus heads were replicated and replaced
- 7 additional heads were anchored together using helical pins
- Terra cotta repairs were crucial to maintaining the building envelope and historic appeal of the building for future investors
- The building was eventually sold to private investors and converted to a boutique hotel

Figure 2: Fractured terra cotta walrus head. Note the degree to which the grout fills the terra cotta void. Credit: Wiss, Janney, Elstner, 1995

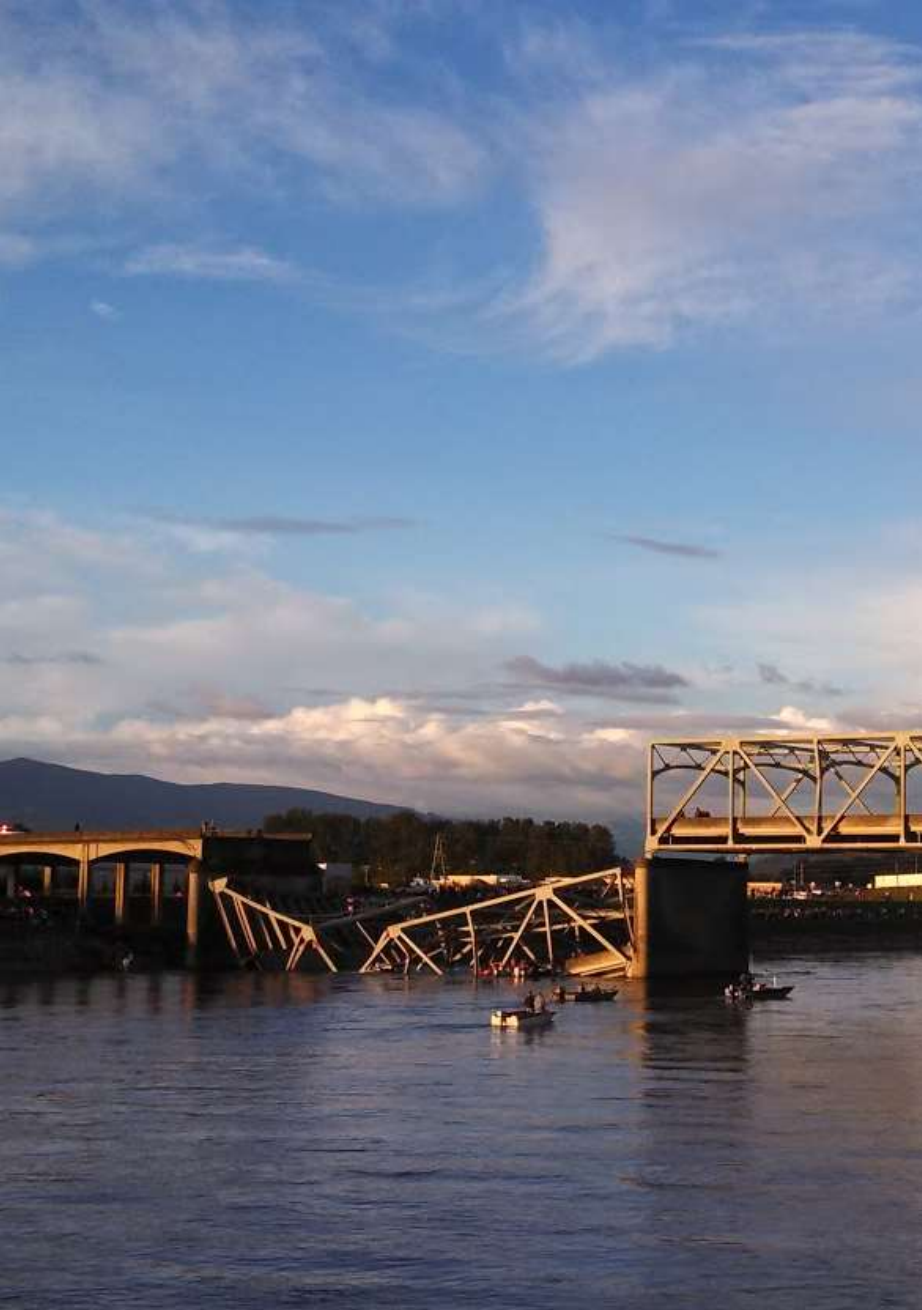
Figure 2: The collapsed I-5 bridge at the Skagit River was “functionally obsolete.” Credit: [http://en.wikipedia.org/wiki/File:05-23-13\\_Skagit\\_Bridge\\_Collapse.jpg](http://en.wikipedia.org/wiki/File:05-23-13_Skagit_Bridge_Collapse.jpg)
